# Manhole Inspection Summary

# Manhole # S71C1\_016MH

Insp Date: **2/12/08 11:11 AM**

**Location** Address: **6500 Detroit Ave.**

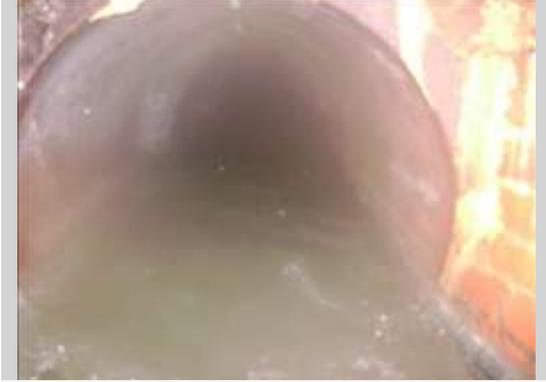
12 O'Clock Outflow

30 in. Circular Gravity Sewer  
Drop Out @ 12 O'Clock

Pipe Height: **28.8** (in.) Rod Only  
Pipe Material: **Clay**  Pipe Lined  
Invert Depth: **40.83** (ft.) Flow Characteristics: **Fast**  
Deposits:  None  Mud  Sludge  Debris  Grease  
Silt Depth: (in.) Deposits Extent:  
Infiltration: **None** Pipe Seal Cond: **Sound**

Drop: **None**
